Inspection Report

Minerals Regulatory Program

Mine Name: Goldstrike Project
Operator or Permittee Name:
USMX, Bankrupt Corporation
Permittee Mailing Address:
None

Permit number: M/053/005
Inspection Date: February 3, 2005

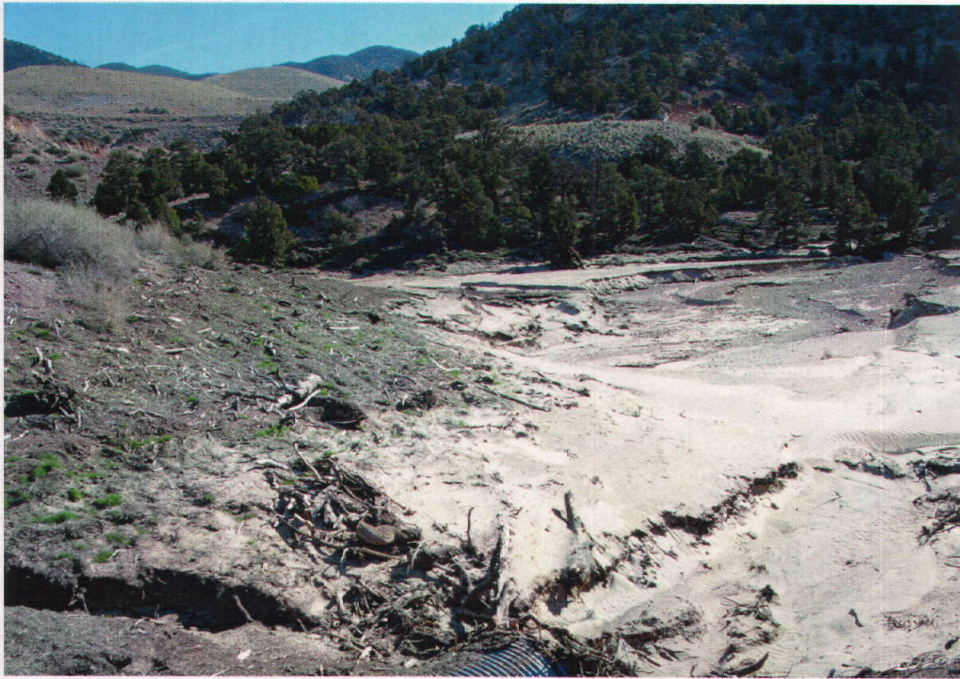
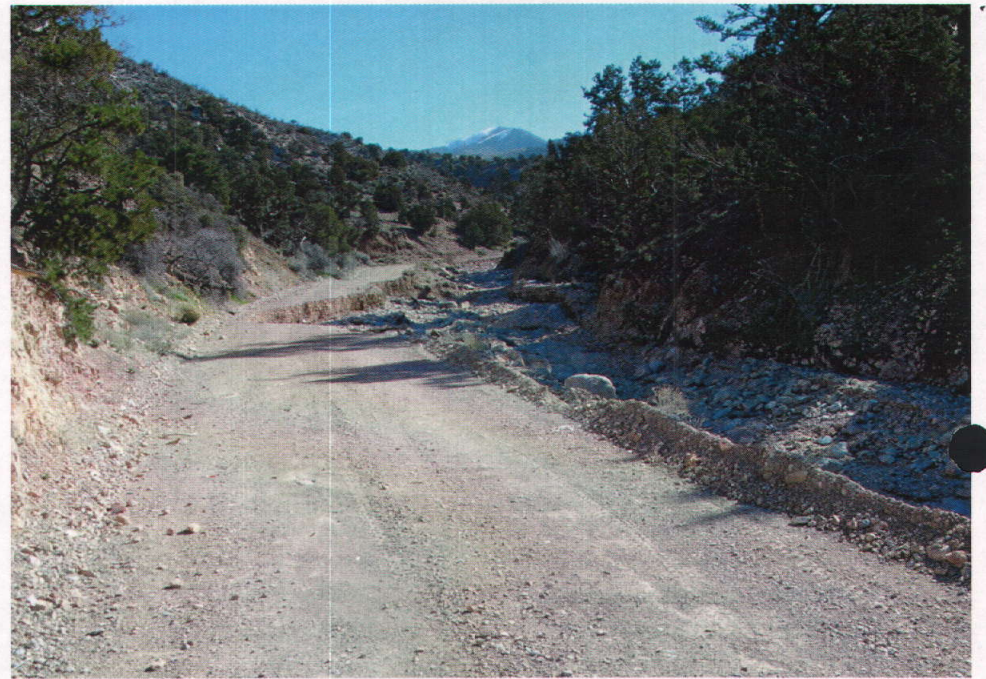
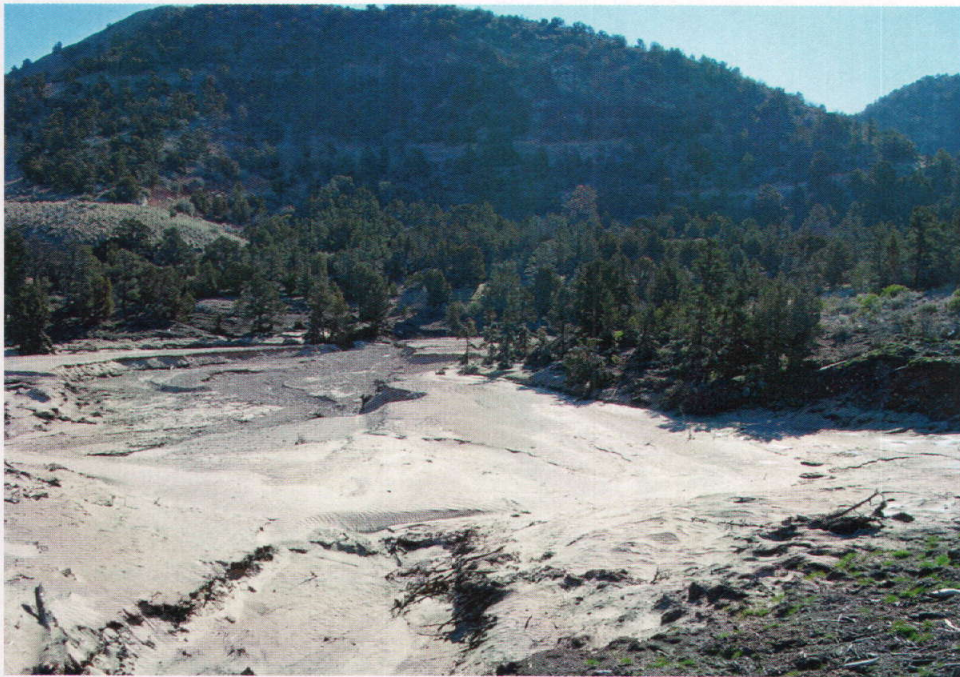
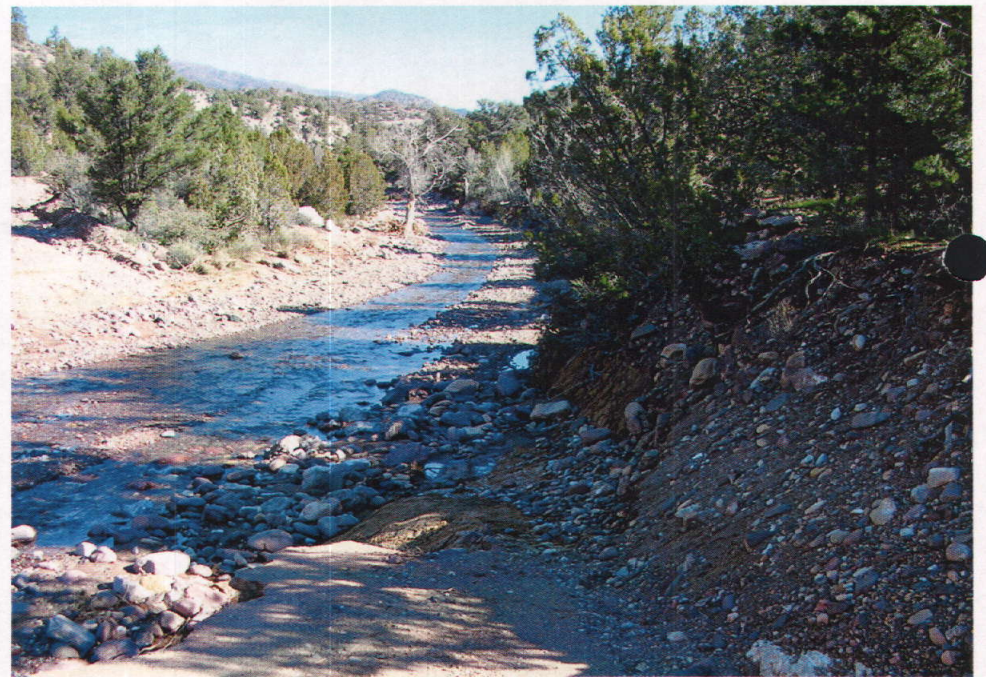
The road crossing at Arsenic Canyon showed that again a large amount of water had backed up above the road. All the humus material that had been deposited before my last visit to the site had been washed away and is now somewhere in Lake Mead, or somewhere along the way. Dan's effort to clean trees and brush that had plugged the culvert during the last high water event probably saved the road in this area during this last storm. Even with both culverts open, the high water still backed up almost to a point of overflowing. The upper four-foot culvert presently has a large tree blocking it, Dan will remove this obstruction during his next site visit. Photos were taken of this area and are included in this report.
